STATE MINING AND GEOLOGY BOARD

EXECUTIVE OFFICER'S REPORT

For Meeting Date: December 8, 2011

Agenda Item No. 7: Public Hearing: Consideration of an Order to Comply Issued by the SMGB to the Big Cut Mine (CA Mine ID #91-09-00XX), Joseph and Yvette Hardesty and Rick Churches (Operators), Joseph and Yvette Hardesty and Rick Churches (Agents), County of El Dorado, for Failure to Correct Violations Pursuant to the Surface Mining and Reclamation Act (Public Resources Code Section 2710 et seq.).

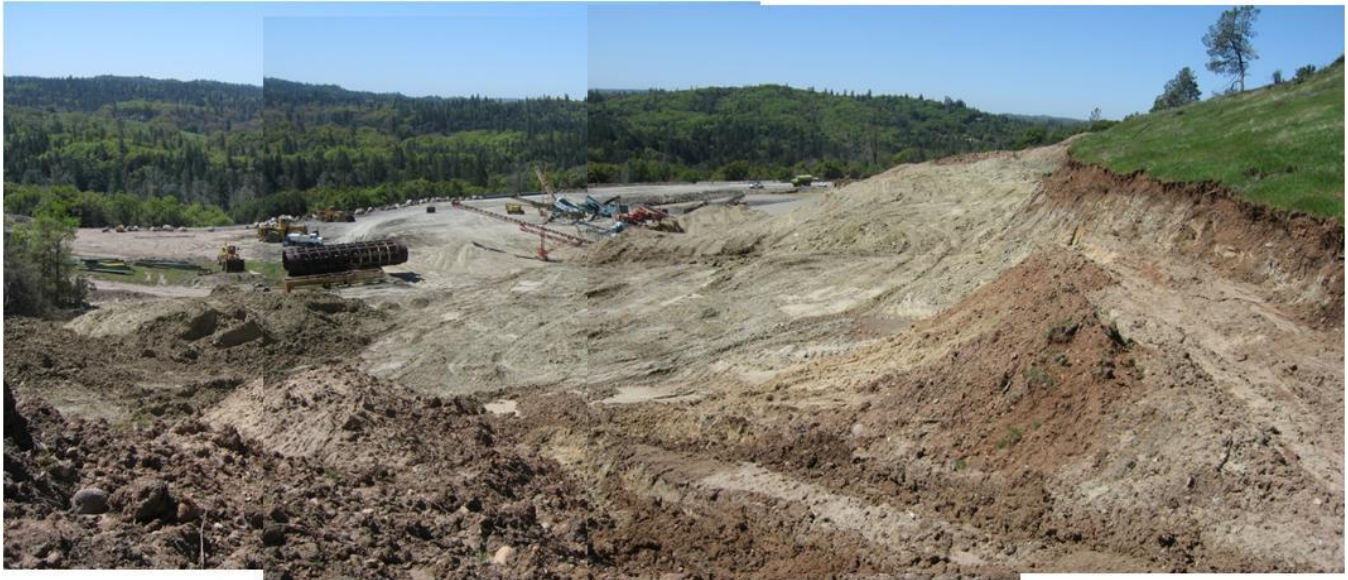
Photograph No. 1. Ongoing excavations, heavy equipment and processing plant (viewing southwest).

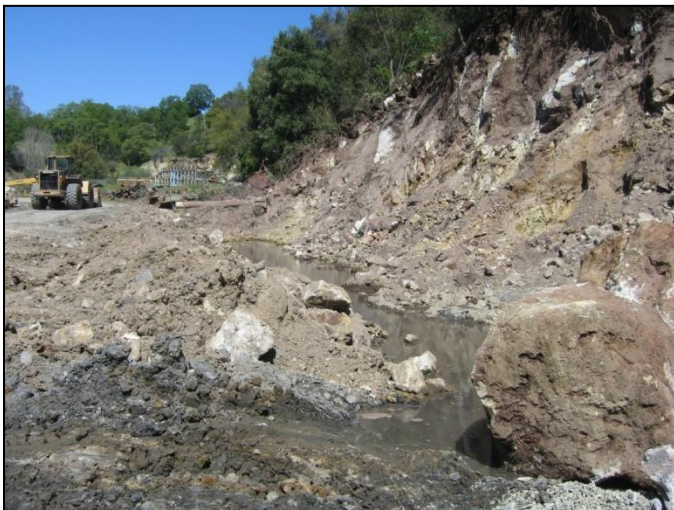
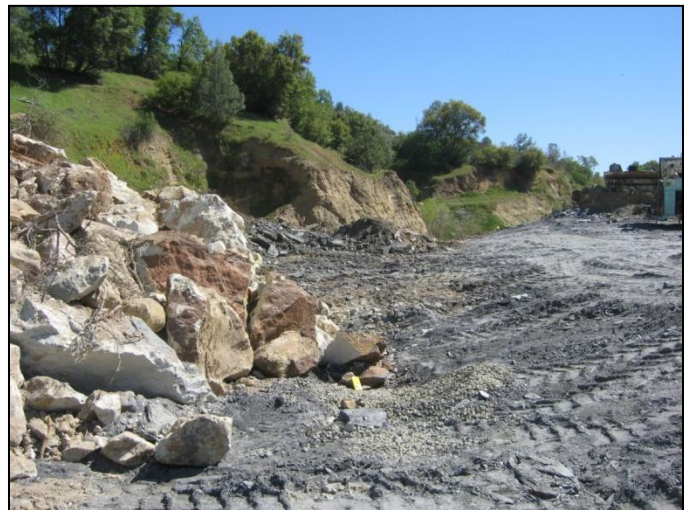
In addition, drainage facility construction activities observed at the Big Cut Mine property on April 29, 2011, are in violation of the SMGB Reclamation Regulations (California Code of Regulations (CCR) Section 3700 et seq.).

Photograph Nos. 2 and 3. Surface water and grading in area of recently installed drainage facility installation.

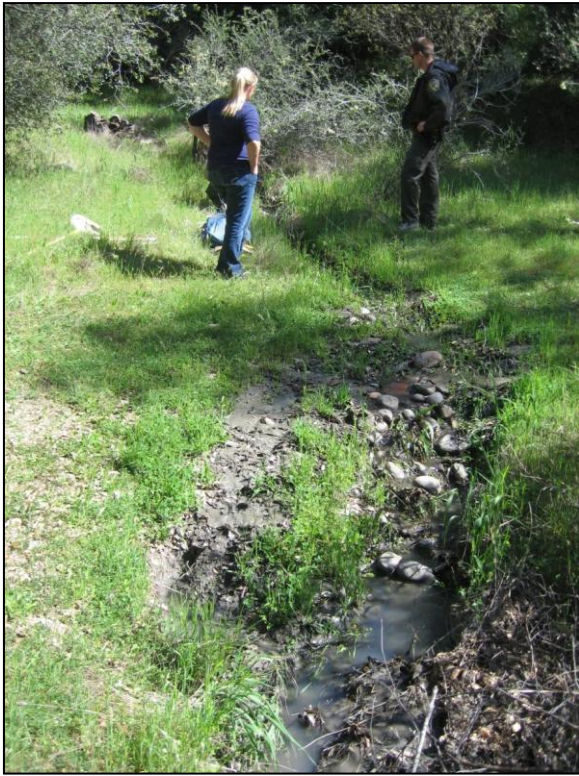
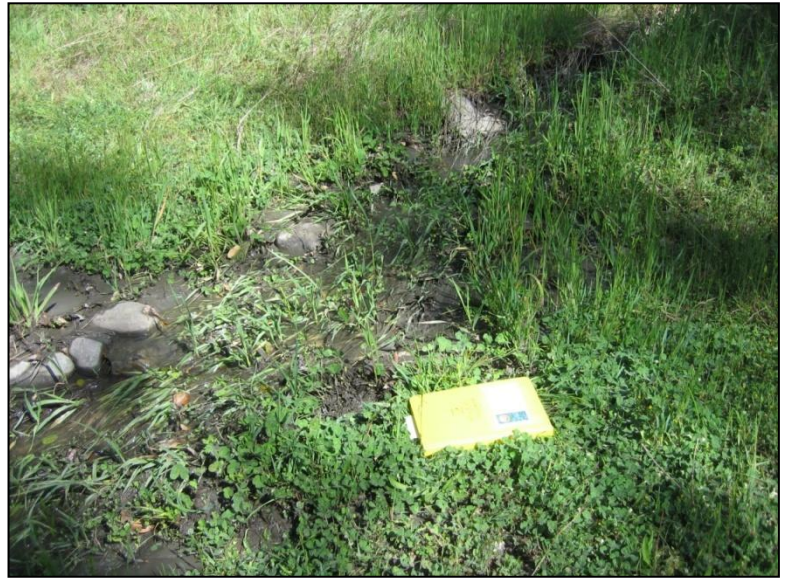
Photograph Nos. 4 and 5. Fine sediment deposition in unnamed watercourse just south of Big Cut Mine.

1. A Remediation Plan to correct the effects of illegal mining activities on the Big Cut Mine site. Such plan should address all areas disturbed by illegal surface mining operations on the Big Cut Mine property during the past year, and shall include specific measures for restoring off-site watercourses impacted by recent sediment discharges.
2. A Financial Assurance Cost Estimate that substantially complies with SMARA and Title 14, California Code of Regulations, Section 3804. (A copy of the SMGB's *Financial Assurance Guidelines* is available on our website to assist you in preparing the cost estimate.) Such Financial Assurance Cost Estimate must be of a sufficient amount to cover all
